FRACTURE FAILURE ANALYSIS IN TIE RODS OF STACKER RECLAIMER

Abstract: This work aimed to analyze the causes of premature failure by fracture of a tie rod of a large rotary forklift or Stacker Reclaimer. A methodology that included visual inspection techniques, macrographic analysis, optical microscopy (OM), Vickers microhardness (HV) measurements, scanning electron microscopy (SEM), semi-quantitative chemical scattering spectroscopy (EDS) and quantitative chemical analysis by optical emission spectrometry and combustion was employed. It could be concluded that the chemical composition of the material and / or the manufacturing process were outside the specification of the material due to the unexpected presence of magnesium and carbon graphite nodules, the latter considered to cause fragility that may have led the material to fracture by fatigue.

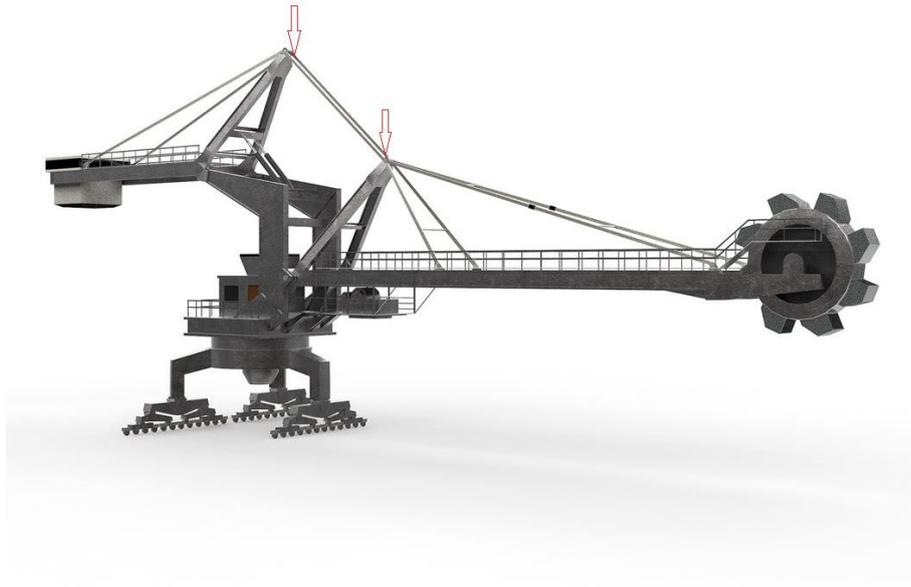
Figure 1 – Stacker Reclaimer, location of tie rods, arrows indicate the fracture site.

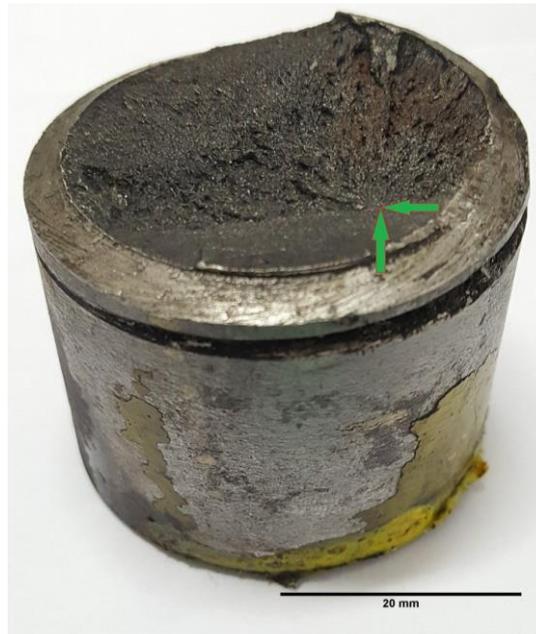
Figure 2 – Sample chosen for analysis, where the tie fracture surface can be observed. The site of probable crack nucleation is indicated with arrows.

Visual inspection of the fractured surface revealed oxidized regions, and the presence of grooves and unevenness, aspects typically associated with the Chevron patterns, recurring in failures due to the fatigue mechanism (SHACKELFORD, 2008). Figure 2 shows the fractured surface, where the marks are well in front of a small relatively flat region, supposedly the place where the crack nucleation process started and later spread (ASM HANDBOOK, 2002). The macroscopic aspect also showed that the probable place of the beginning of the failure was located in a machining groove in the threaded region of the tie rods. This region has a higher stress concentration due to the manufacturing process (BIASIBETTI, 2018).

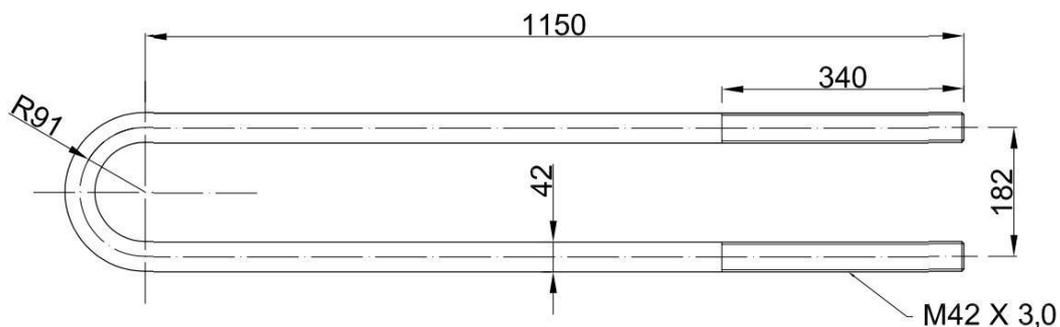
Figure 3 – Technical drawing of Stacker Reclaimer tie rods. Data provided by the company. Dimensions in mm. The fracture occurred on the threaded region, close to the interface of the unthreaded region.

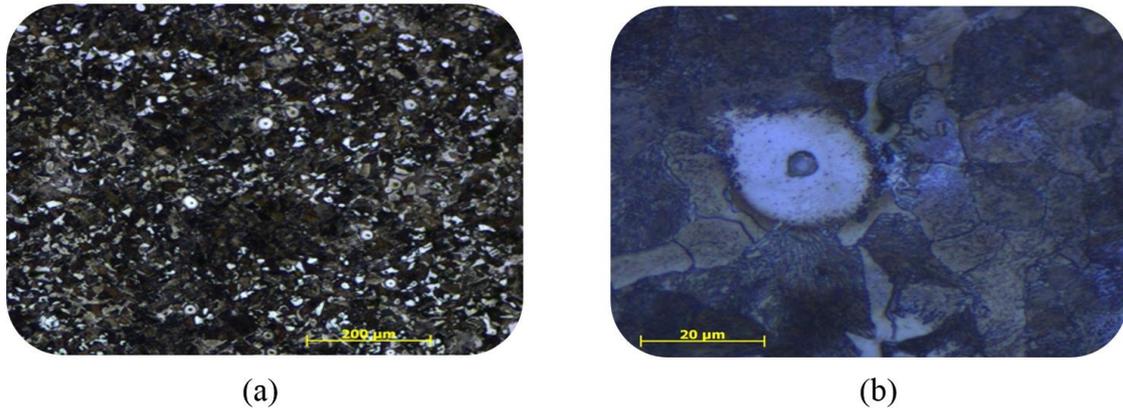
The micrographic aspects obtained (Figure 5), showed that the microstructure of the material was in accordance with the specification for tie rods, i.e., a steel of type AISI 1050. All the regions analyzed presented a microstructure composed of grains of pearlite and ferrite (Figure 5(a) – pearlite are dark grains, and ferrite are light grains). The phases distribution is homogeneous and uniform, with ferrite being present in a smaller amount (ASM HANDBOOK, 2004). However, it was also observed the unexpected presence of numerous regions with an aspect typically associated with graphite nodules, which are surrounded by a carbon-depleted ferritic region (Figure 5(b)). Therefore, the microstructure of the material was not perfectly within specifications. Those nodules are typically present in nodular cast irons, and are associated with a combination of graphite alloying elements and cooling rates in the manufacturing process. The elements that favor the formation of graphite are silicon; cerium; and magnesium; however, steels of the type AISI 1050 do not have considerable percentages of those elements. The assumption of the presence of these elements was raised due to the graphite potential they have (OKAMOTO, et. al., 1984; SOINSKI, 2012).

Figure 5 – Microstructural aspects obtained from the OM, Nital 5%. Region near the surface of the sample (a); and near of the center (b). Highlight for the graphite nodule surrounded by ferrite and the lamellar aspect of the pearlite.

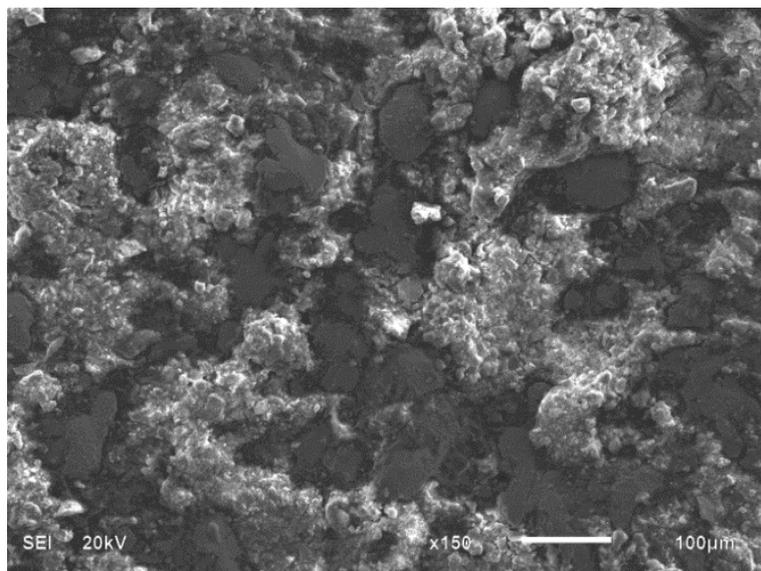
The fractographies obtained in SEM did not allow obtaining information that characterized typical aspects of failure due to fatigue, both due to the oxidation present on the sample surface and due to high concentration of carbon nodules identified in several points of the fractured surface. The presence of nodules was already indicated by the micrographic aspects obtained from the OM and was confirmed by chemical analysis in the EDS technique. Figures 6 and 7 shows examples of the results obtained for the fractographic aspects and the spectrum of characteristic energies for several regions analyzed.

Figure 6 – Fractographic aspect obtained for all analyzed regions of the fractured surface. The darkest and most flat surface on the imagen are graphite nodules. SEM in secondary electron mode.

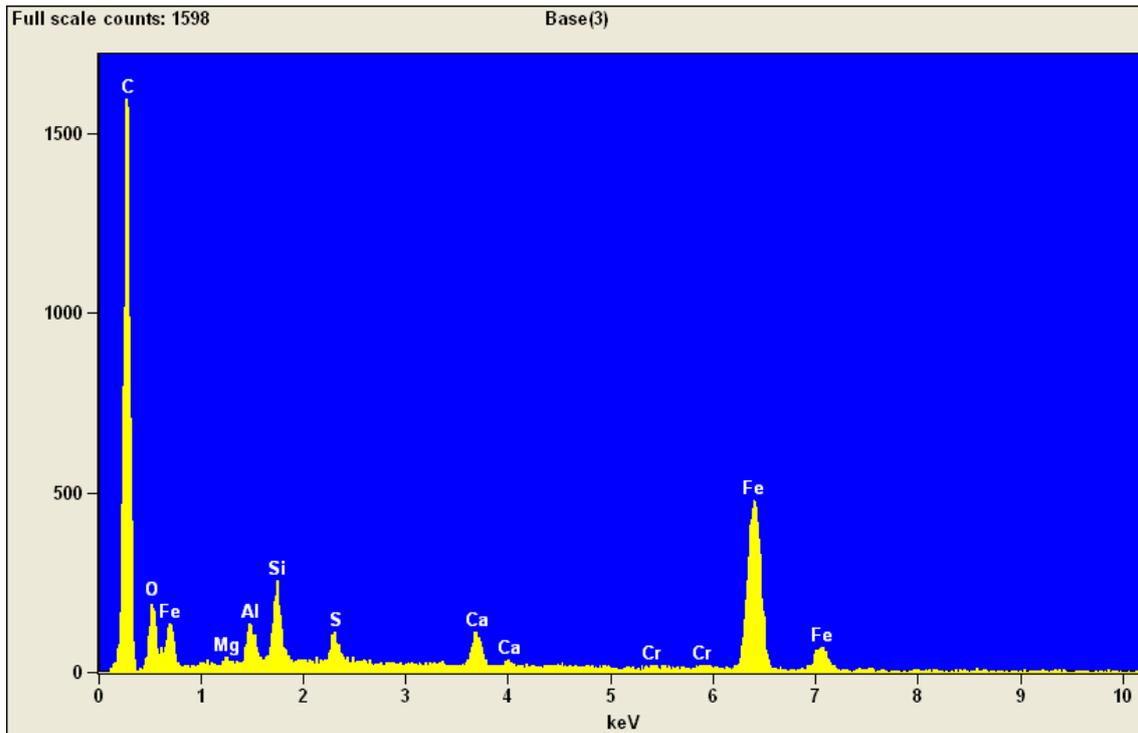
Figure 7 – Spectrum of characteristic energies obtained for several regions analyzed. Essentially the elements Fe, C, Si, Al and Cr were identified. The Ca element can be considered a contaminant on the surface.

Although carbon is difficult to identify by EDS, its high content allowed the confirmation of its presence at high peaks. In addition, the presence of a small magnesium concentration was observed. This presence was not expected for AISI 1050 steel and it could be responsible for the separation of carbon from the cementite and its coalescence, forming the graphite nodules (KIRBY, 1995; SOINSKI, et al., 2014).

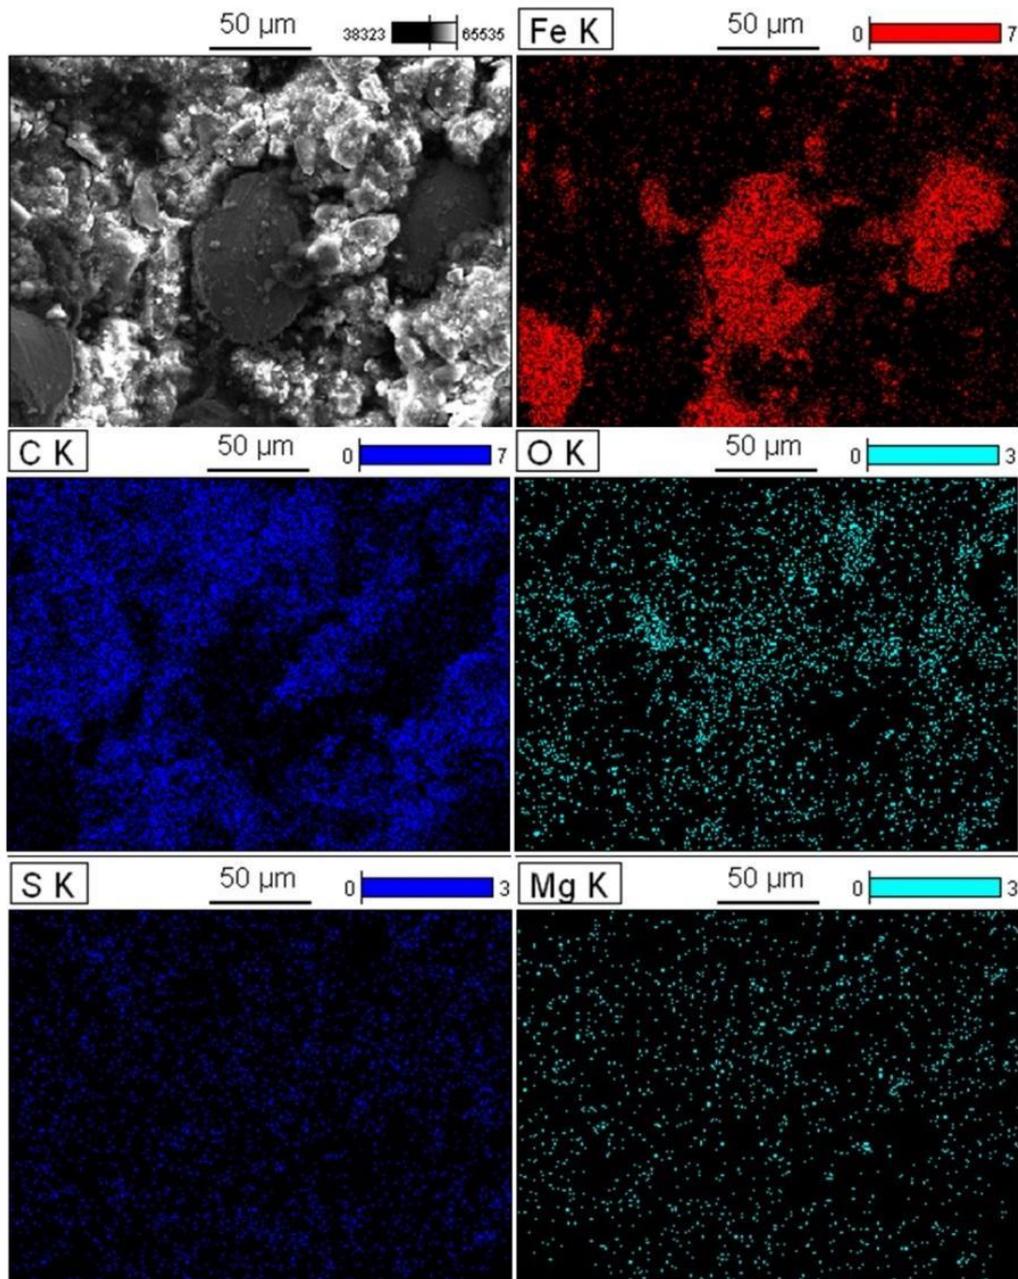
Figure 8 exemplifies the distribution of chemical elements on the surface of the fractured sample through color images (EDS mapping). It is possible to observe that the regions with the presence of graphite nodules were essentially covered by iron, an element with greater atomic weight than carbon, and easier to detect than the latter.

Figure 8 – EDS mapping analysis. The upper left image represents the region analyzed, the others the maps for each chemical element analyzed. The iron (red) was found to be abundant around the graphite nodules. Magnesium was evenly distributed, according to the lower image on the right.
